BRE Test Report

Determination of the uplift resistance of Carapace Slates to EN 14437

Prepared for: Martyn Lucas, SunScape Systems Ltd

Report Number: P102525 – 1001 Issue 1

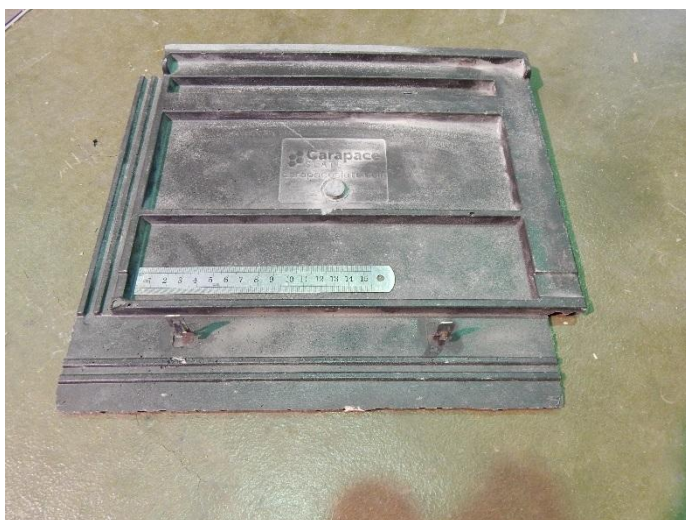
Figure 2 view on bottom surface of Carapace Slate showing integral fixing brackets

Figures 1 and 2 show views of the Carapace Slates.

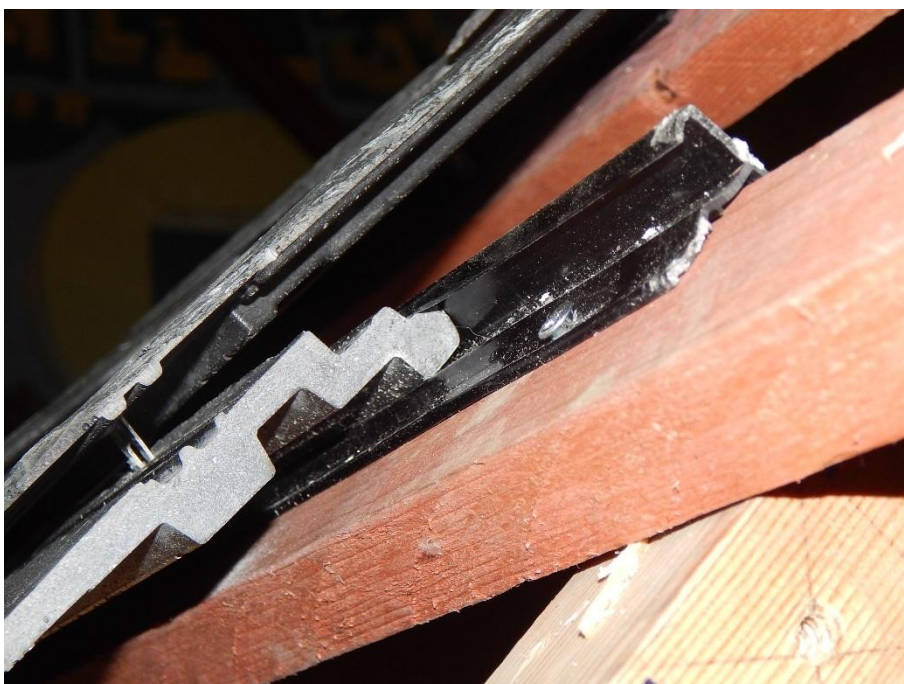
Figure 5 Integral clip disengaged from slate below

The slates failed due to either the integral slate clip disengaging from the slate below or the head of the slate disengaging from the metal rail. Figures 5 and 6 show the failure slates.

Applied force (N)	Failure Mode (see Figure 4 for key to slates)
3767	No 8 slate right hand side clip disengaged No 13 slate right hand side clip disengaged
4709	No 9 slate right hand side clip disengaged
5023	No 14 slate right hand side clip disengaged No 15 slate – head of slate disengaged from metal rail No 16 slate – head of slate disengaged from metal rail
